**Flood Control Project Maintenance****2013 Structure Summary Report****Overall Unit and Item Ratings****Lower San Joaquin Levee District****Ash Slough Drop Structure No. 1**

Overall Unit Rating	Rated Item	Item Rating
<b>A</b>	Photo Documentation	N
	Vegetation & Obstructions	A
	Shoaling / Sedimentation	A
	Erosion / Bank Caving	A
	Revetments	M
	Encroachments	A
	Culverts: Inlets / Outlets	N
	Culverts: Breaks / Holes / Cracks	N
	Metal Pipes	N
	Trash Racks	N
	Flap Gates	N
	Sluice/Slide Gates	N
	Electric Gate Operators	N
	Manual Gate Operators	N
	Concrete Surfaces	A
	Concrete Tilting / Settlement	A
	Concrete Foundations	A
	Security Fencing	N
	Closure Structures	N
	Trash Rakes	N
	Other Metallic Items	N
	Monolith Joints	A
	Safety	A
	Operation & Maintenance Manual	A

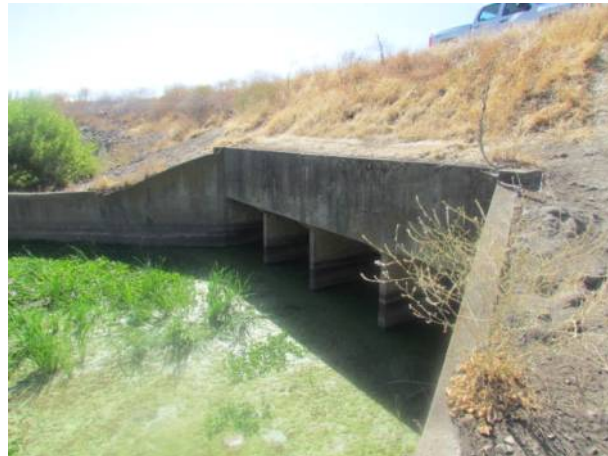
Levee Mile Report Line	7
Start Levee Mile	0.00
End Levee Mile	0.00
Location	
Category	Structures
Item	Culverts: Inlets / Outlets
Looking north at inlet of Sand Slough structure.	
richard_t_20130715_084.JPG

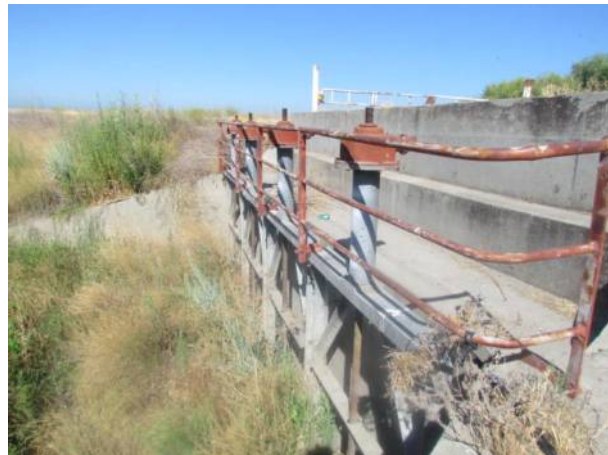
Levee Mile Report Line	12
Start Levee Mile	0.00
End Levee Mile	0.00
Location	
Category	Structures
Item	Sluice/Slide Gates
Looking east at gates on downstream side of Sand Slough structure.,	
richard_t_20130715_085.JPG

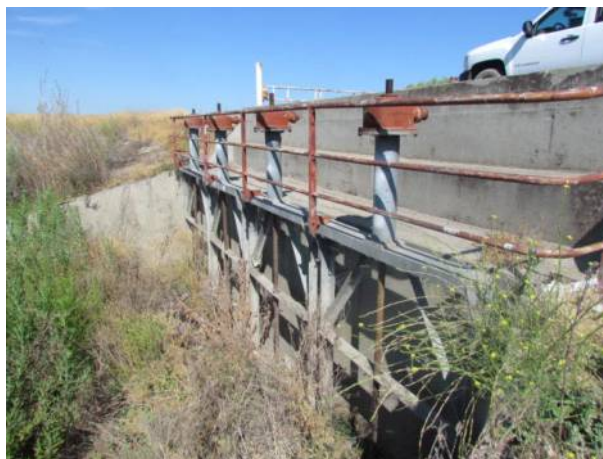
Richard\_t\_20130730\_139.JPG

Looking northeast at downstream side of structure.

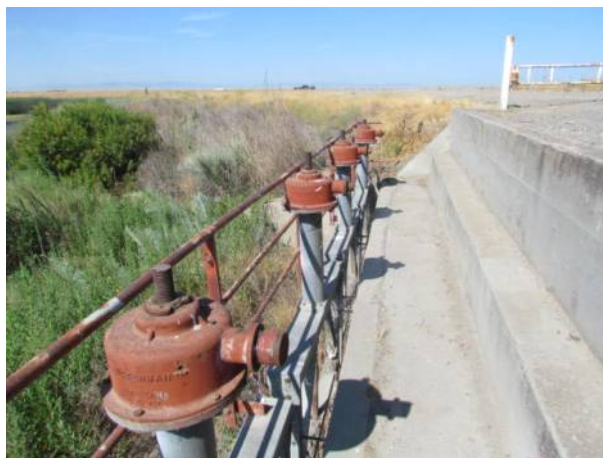
Richard\_t\_20130730\_138.JPG

Looking southeast at manual gate operators on upstream side of structure.

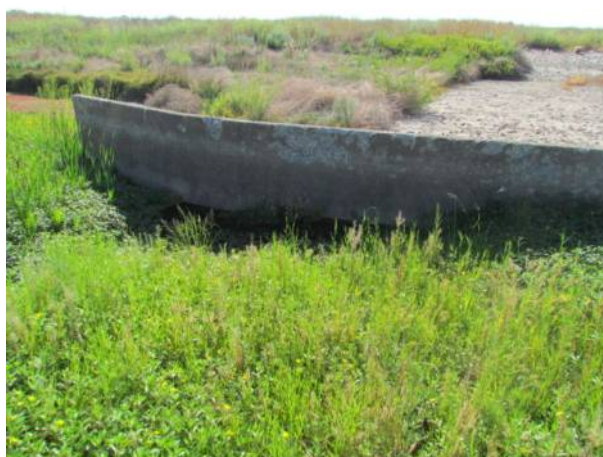
Richard\_t\_20130730\_136.JPG

LMR No.	Levee Mile		Category	Item	Location *	Rating **	Action/Comment	GPS Latitude/Longitude		Issue No.
	Start	End						Start	End	Photo
15	0.00	0.00	Structures	Concrete Surfaces		M	Inspector Comments: Chips on SJ structure surface from gun shots; structure is being used as target practice. Cracking on Sand Slough structure outlet side on left and right corner. Minor cracking on Sand Slough structure.	37.112337 ° -120.589543 °	37.112337 ° -120.589543 °	15 Y
16	0.00	0.00	Structures	Concrete Tilting / Settlement		A	Inspector Comments: No visible movement along this structure.	37.112337 ° -120.589543 °	37.112337 ° -120.589543 °	16
17	0.00	0.00	Structures	Concrete Foundations		A	Inspector Comments: No visible undermining present or near this structure.	37.112337 ° -120.589543 °	37.112337 ° -120.589543 °	17
18	0.00	0.00	Structures	Security Fencing		N	Inspector Comments: Item does not exist on this structure	37.112337 ° -120.589543 °	37.112337 ° -120.589543 °	18

Looking south at chips on left wing wall on downstream side of structure.

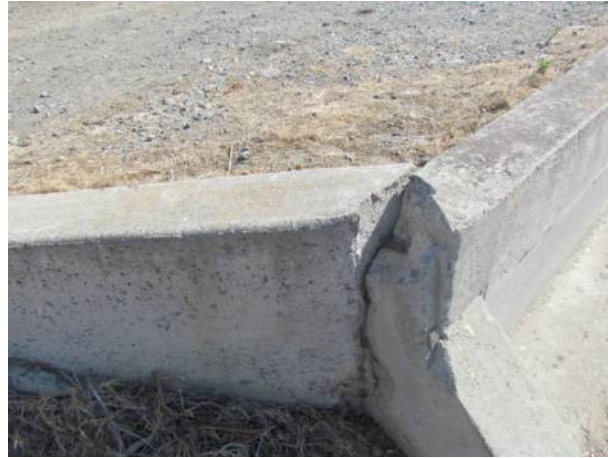
Richard\_t\_20130730\_137.JPG

Looking northwest at cracking on left corner joint.
